# Manhole Inspection Summary

Manhole # S17A1\_020MH

**Location** Address: **2700 desoto rd** Cross Street: **washington bd**

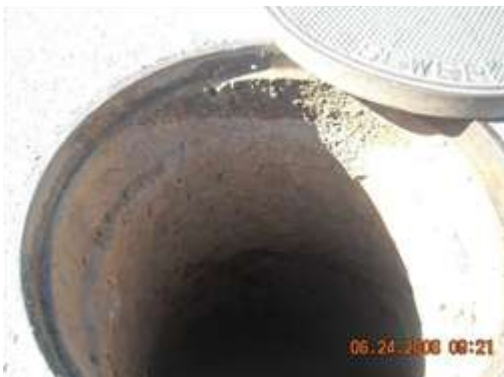
Misc

**Manhole** Type: **Inline** Location: **Roadway** Ground Conditions: **Dry**  
☐ Prev. Rehab Weather: **Dry** Subject To Ponding: **Sheeting**

inflow evidence from sheeting

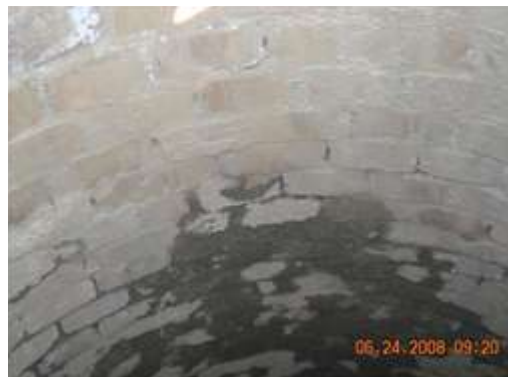
Defect 4

Infiltration: ☐ None ☐ Joint ☐ Cracks ☐ Mortar ☐ Roots ☒ Wall

infiltration @ corbel wall

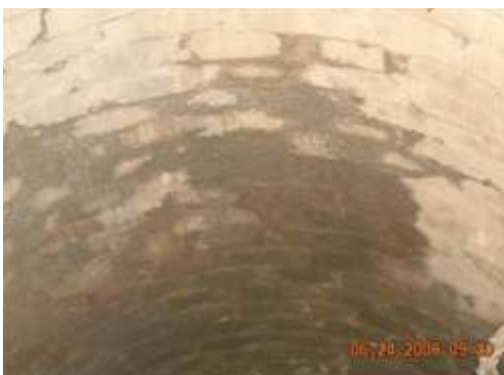
Defect 3

Infiltration: ☐ None ☐ Joint ☐ Cracks ☐ Mortar ☐ Roots ☒ Wall

infiltration @ barrel wall

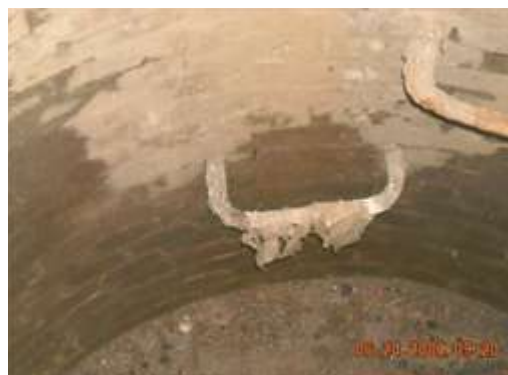
Defect 2

**Surcharge** ☒ Evidence Of Surcharge Depth: **3** (ft.) ☐ Active Surcharge Present

surcharge evidence

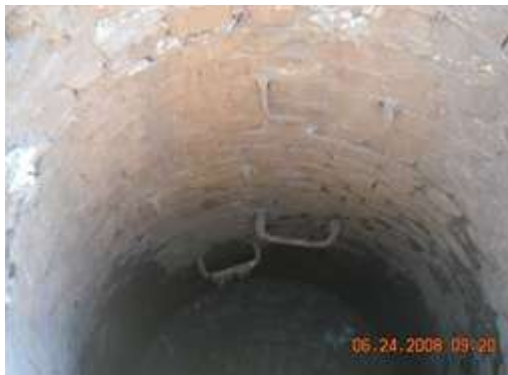
### Defect 1

**Steps** Count: **2** Missing: **3** ☒ Corroded

corroded & missing steps

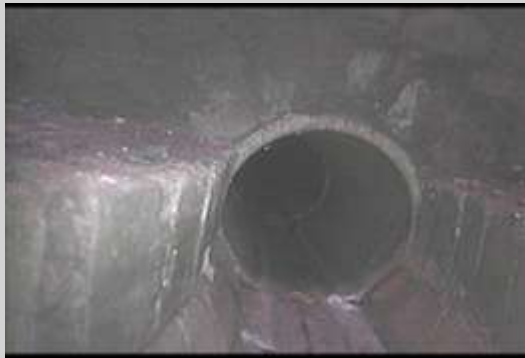
12 O'Clock Outflow

8 in. Circular Gravity Sewer  
Pipe Out @ 12 O'Clock

Pipe Height: **8.4** (in.) Rod and Bar (Angled)  
Pipe Material: **Clay** ☐ Pipe Lined  
Invert Depth: **8.90** (ft.) Flow Characteristics: **Slow**  
Deposits: ☒ None ☐ Mud ☐ Sludge ☐ Debris ☐ Grease  
Silt Depth: **0** (in.) Deposits Extent:  
Infiltration: **None** Pipe Seal Cond: **Sound**

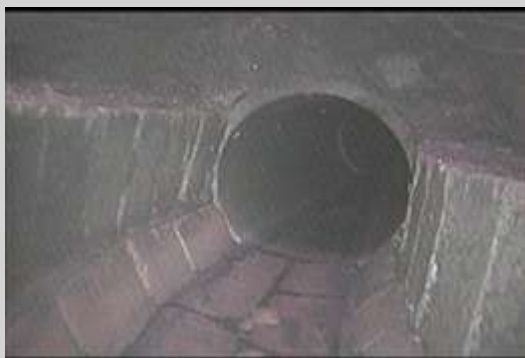
9 O'Clock Inflow

8 in. Circular Gravity Sewer  
Pipe In @ 9 O'Clock

Pipe Height: **8.4** (in.) Rod and Bar (Angled)  
Pipe Material: **Clay** ☐ Pipe Lined  
Invert Depth: **8.76** (ft.) Flow Characteristics: **Slow**  
Deposits: ☒ None ☐ Mud ☐ Sludge ☐ Debris ☐ Grease  
Silt Depth: **0** (in.) Deposits Extent:  
Infiltration: **None** Pipe Seal Cond: **Sound**
